Home Inspection Report

55522 ND ST SW
Centralia, Washington

Prepared for: Mr & Mrs Sample

Prepared by: Sound Choice Inspections
2120 Swift Creek Lane SW
Olympia, WA 98512
360-561-0951
Licensed Home Inspector #226

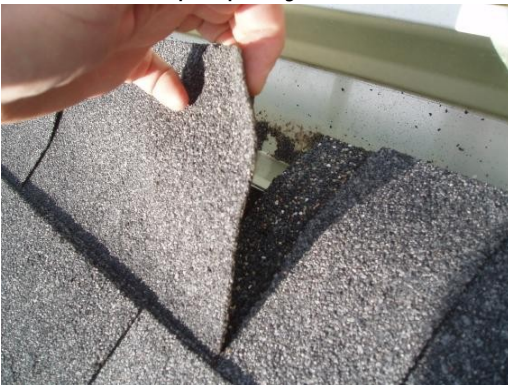
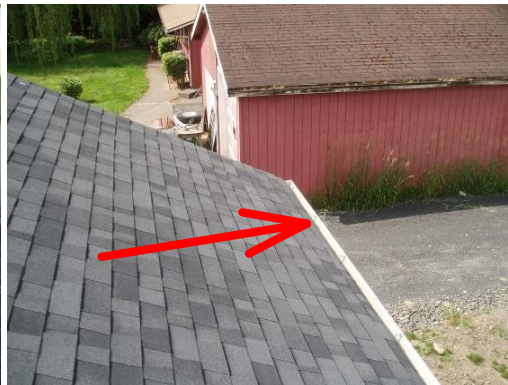
3. **Main home & garage Roof Surface Material:** Asphalt shingle _ The first and starter courses were seen improperly lined up in one location. This condition may result in water getting under the roofing. Recommend that a licensed roofing contractor repair this area and verify that the remainder of the roof is properly installed.

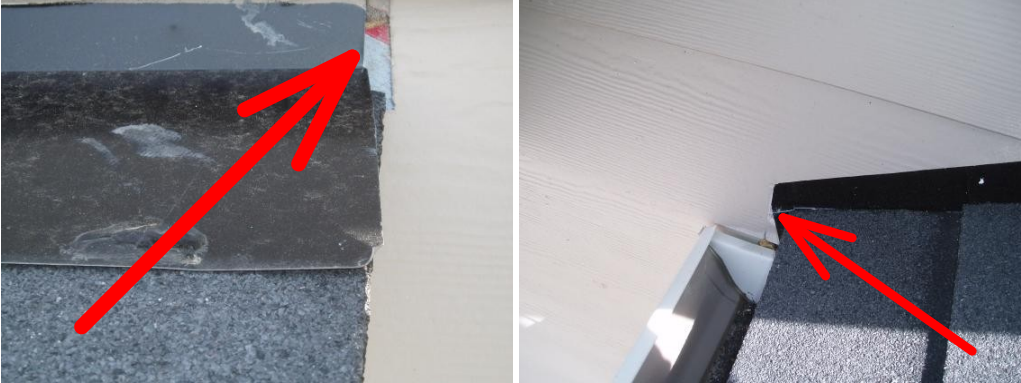
4. Flashing: Steel, brown _ The kick out flashing at the corners of the front and garage bump outs are not properly sealed and water may be able to enter the walls at these locations. Recommend a licensed roofer repair as needed.

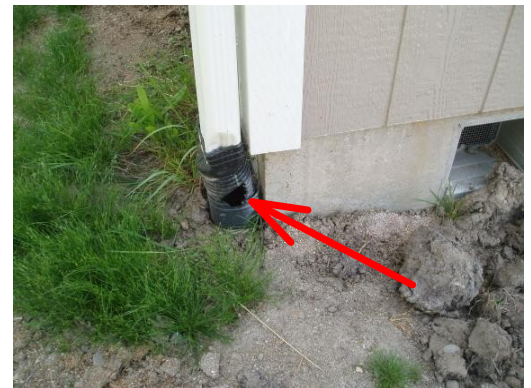
5. Leader/Extension: Downspouts are connected to drain pipes. This drain pipe at NE corner is damaged. Recommend it be repaired or replaced.

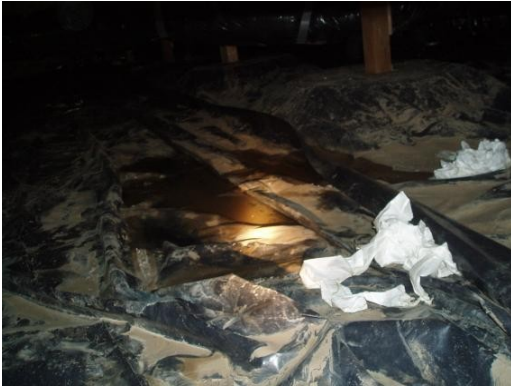
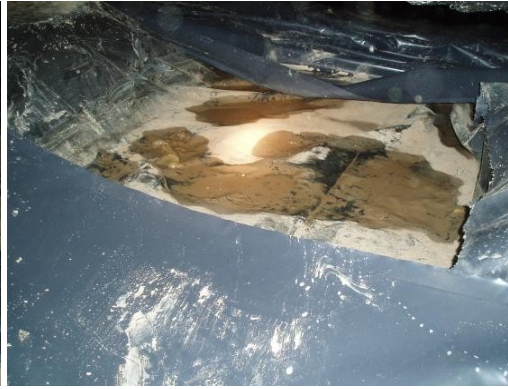
10. Under entire home Crawl Space Moisture Penetration: There is standing water in the crawl area. A qualified drainage contractor is recommended to evaluate and estimate repairs

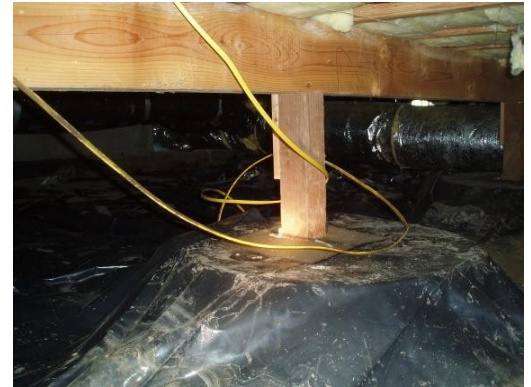
11. Under entire home Crawl Space Electrical There are wires hanging down in the crawl area. Recommend that they be properly fastened to the floor framing or post in a workman like fashion. Recommend a licensed electrician properly secure and elevate these wires to the framing in a workman like manner.

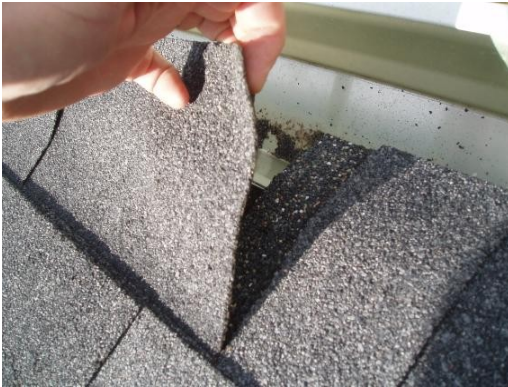
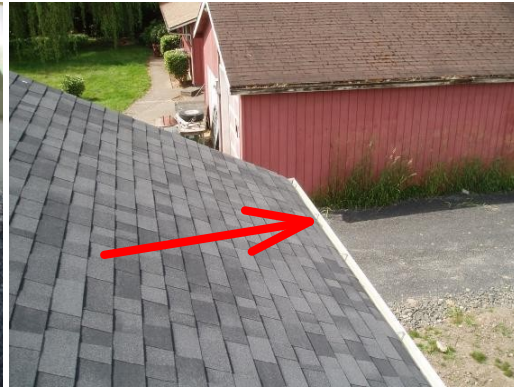
Main home & garage Roof Surface

Marginal Material: Asphalt shingle _ The first and starter courses were seen improperly lined up in one location. This condition may result in water getting under the roofing. Recommend that a licensed roofing contractor repair this area and verify that the remainder of the roof is properly installed.

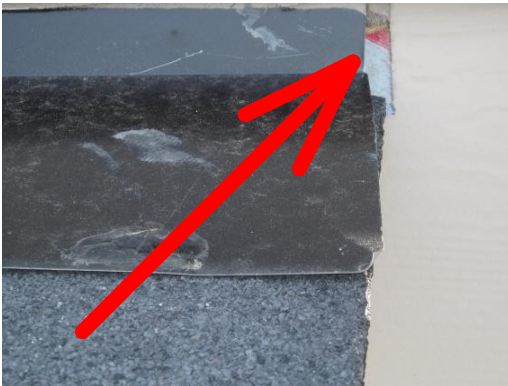
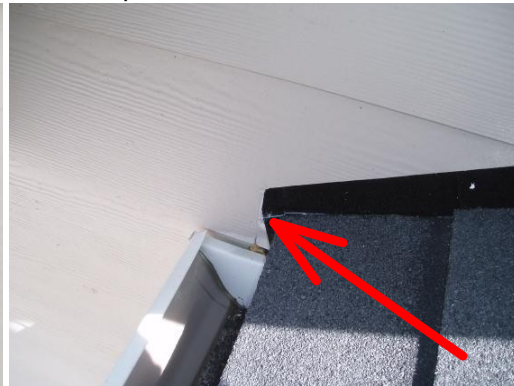
Marginal Flashing: Steel, brown _ The kick out flashing at the corners of the front and garage bump outs are not properly sealed and water may be able to enter the walls at these locations. Recommend a licensed roofer repair as needed.

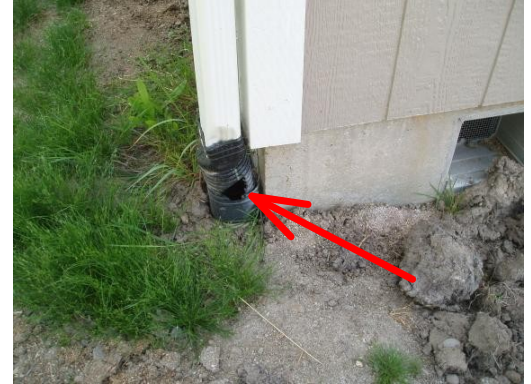
Acceptable Downspouts: Steel
Marginal Leader/Extension: Downspouts are connected to drain pipes. This drain pipe at NE corner is damaged. Recommend it be repaired or replaced.

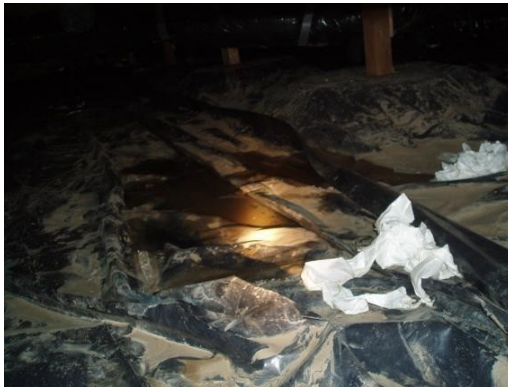
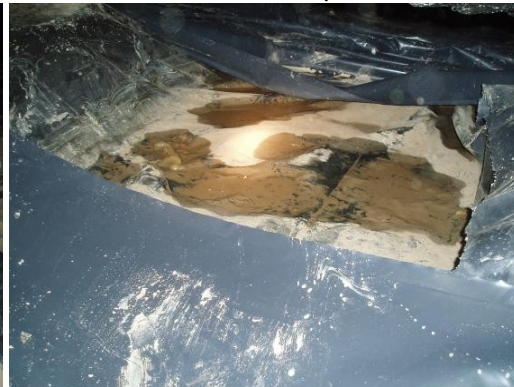
Acceptable	Access: Wood cover
Defective	Moisture Penetration: There is standing water in the crawl area. A qualified drainage contractor is recommended to evaluate and estimate repairs

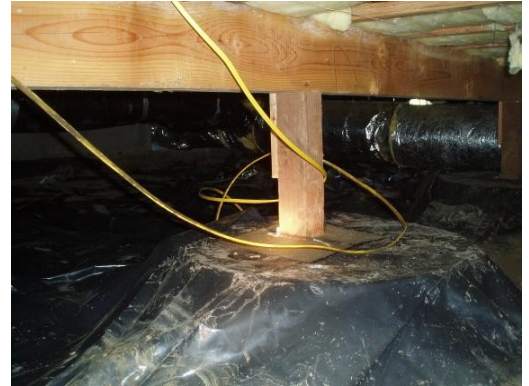
Electrical There are wires hanging down in the crawl area. Recommend that they be properly fastened to the floor framing or post in a workman like fashion. Recommend a licensed electrician properly secure and elevate these wires to the framing in a workman like manner.
